Earth: Killer of Micro-Electronics

Mysterious energy pulses

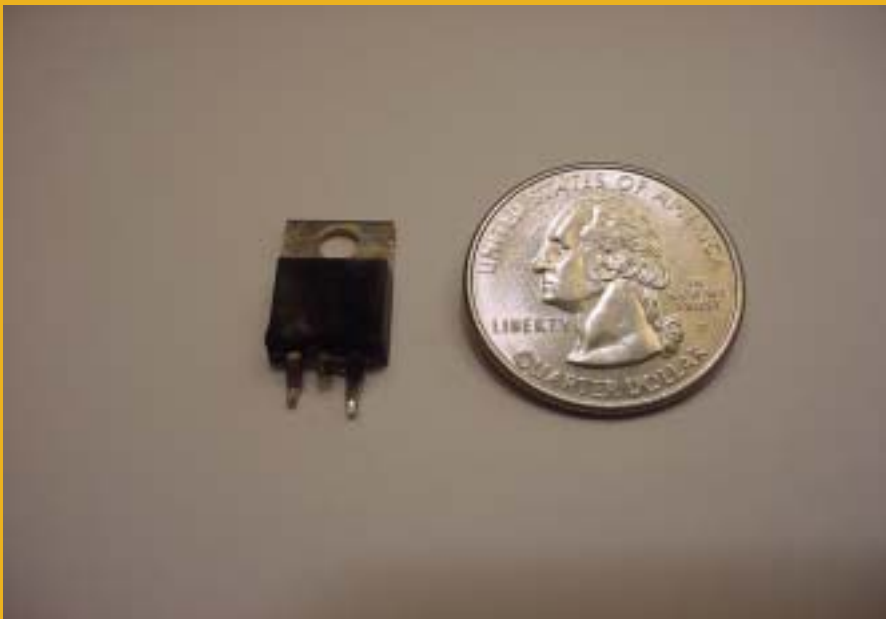
View of burned Field Effect Transistor (FET) commonly used in DC to DC converter power supplies.

We then focused on analysis of the damage to the FET's. The damage mirrored an extreme condition of 120C thermals where a phenomena of 'excess electron & hole carriers' interfere with the normal conductive behavior of the semiconductor (conduction becomes 'intrinsic'). The device could self destruct in these extremes. Yet thermal testing

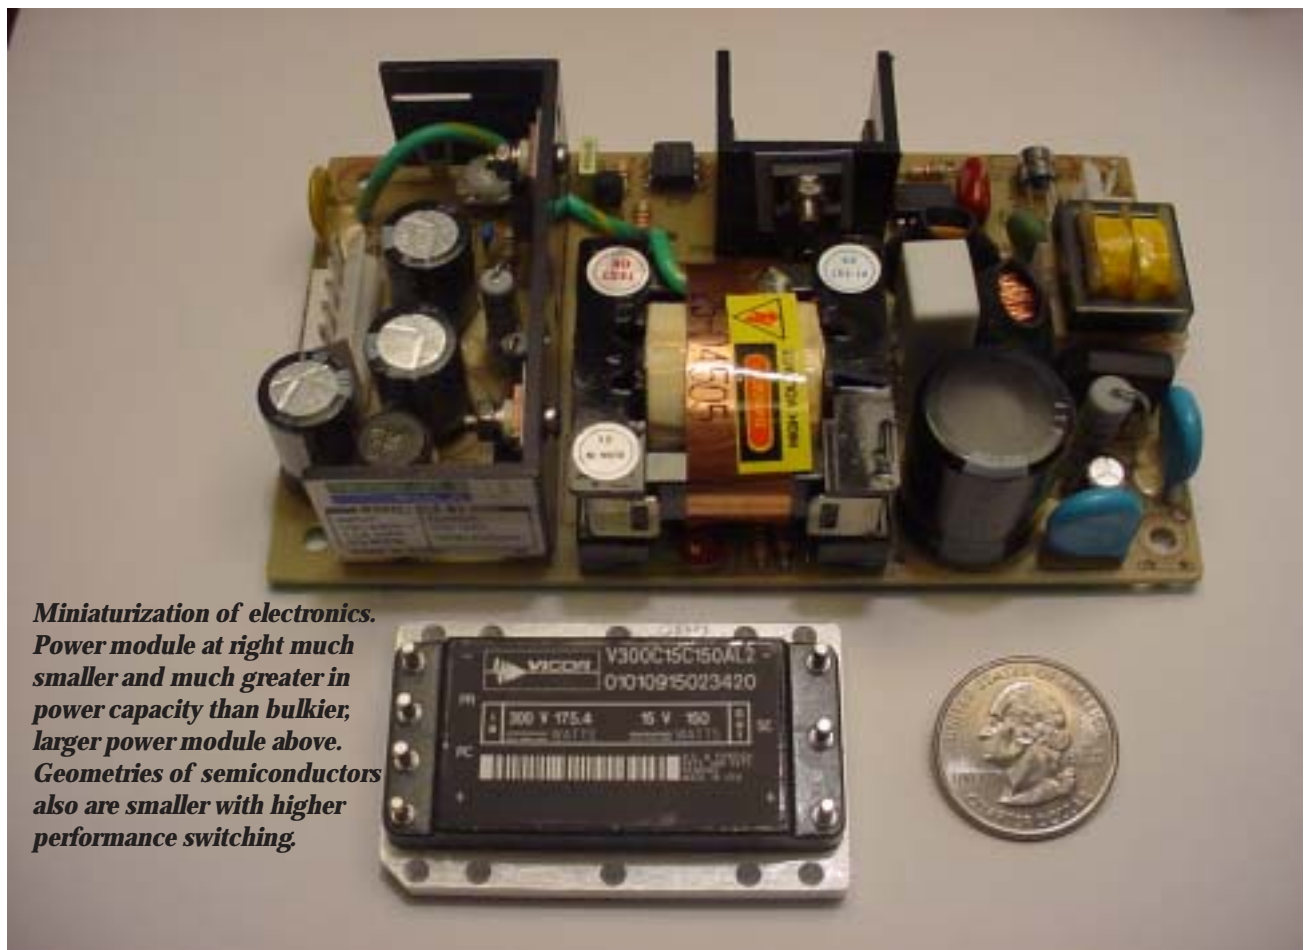
Miniaturization of electronics. Power module at right much smaller and much greater in power capacity than bulkier, larger power module above. Geometries of semiconductors also are smaller with higher performance switching.

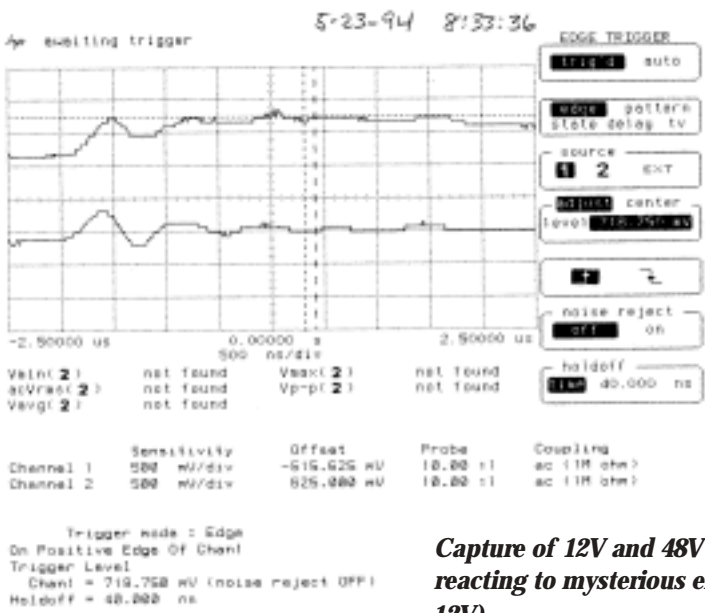
Capture of 12V and 48V output from power modules reacting to mysterious energy. (upper trace 48V, lower 12V).

By triggering on any small disturbance on either of the 12V or 48V regulated power we could then capture incoming AC lines for clues. Waiting for a trigger could take days. When one finally registered we observed that the 12V and the 48V were ramping upward as if the power module was pumping energy as fast as it could convert. Needless to say this was well out of operating conditions. Looking at the incoming AC captured waveform there was a near perfect sine wave - nothing. Either something of great energy was getting into the power module - somehow - or the power module itself had a very intermittent design defect.

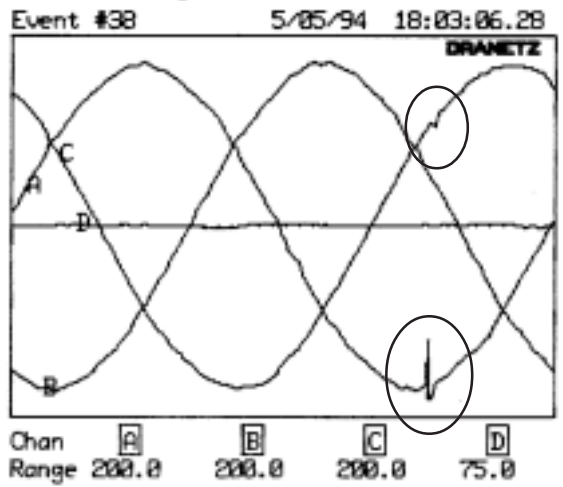
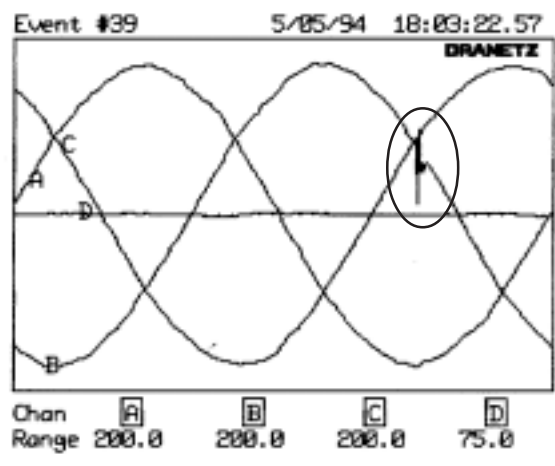
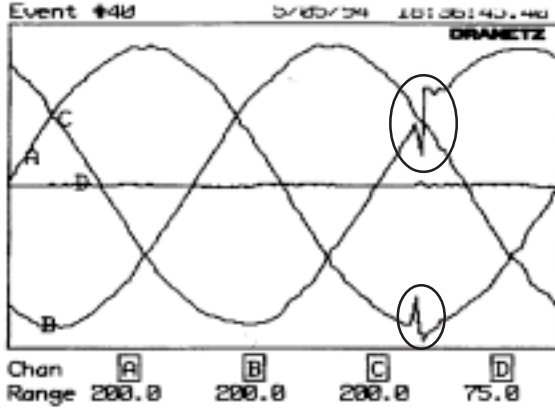
Facility 3phase AC power with recorded 'transients'. These were eliminated as failure mechanism source to the mysterious energy.

In parallel to our efforts a consulting company specializing in power analysis was hired to monitor the building AC power to our production facilities. Dranetz 3 phase AC instruments were installed on the lab AC power to capture any disturbances. Their instruments captured a number of typical transients on the AC power but the AC/DC filtering section attenuated the transients as designed (some of the captures shown on next page). Comparing their trigger log of timestamped captures also identified that the power module anomalies were not

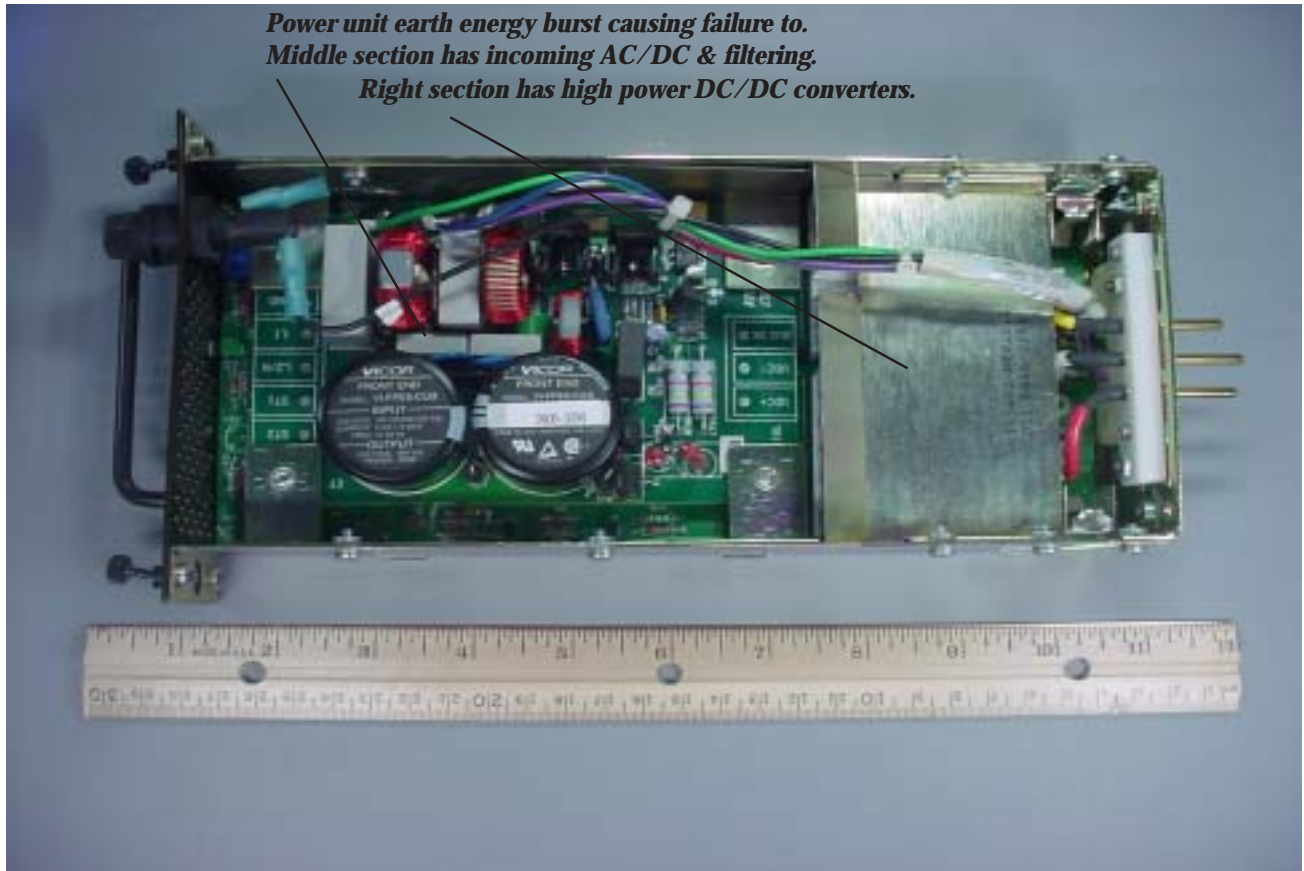
***Power unit earth energy burst causing failure to.
Middle section has incoming AC/DC & filtering.
Right section has high power DC/DC converters.***

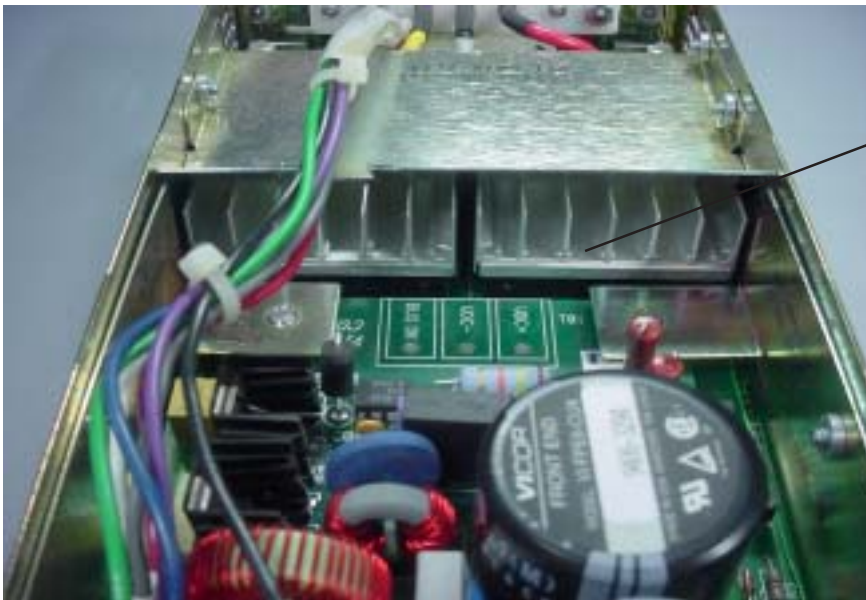
Switcher FET burned inside of power module (DC/DC converter).

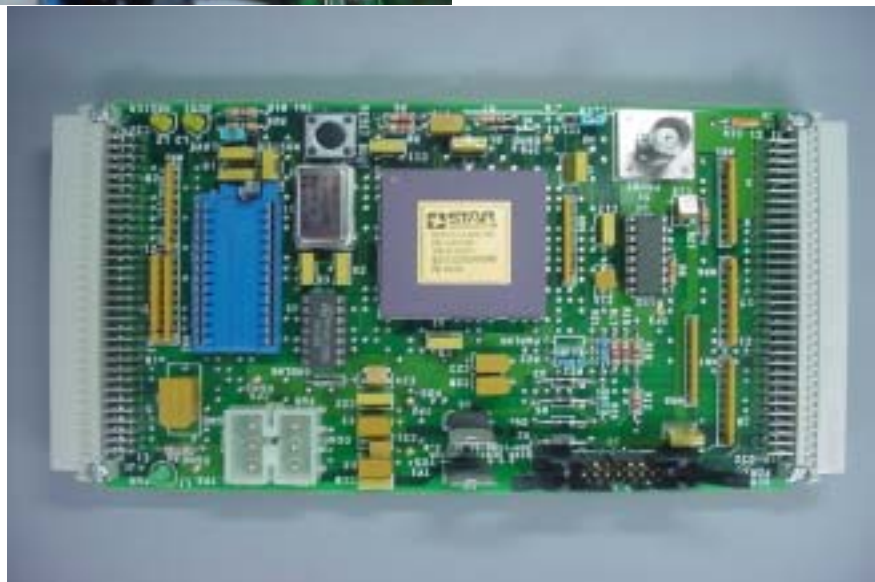
Digital Signal Processor unit. Used to analyze and trigger on energy burst as it entered system.

A triggering mechanism 'breakthrough' developed when a special signal observation method was constructed. Taking a digital signal processing (DSP) board, sense divider resistors, and writing custom filter code for the DSP unit created a flexible trigger unit which allowed observation of very small variations on the incoming AC power. As events were far and few between, the new capture system was tested in the lab to ensure it was operating properly. Validating to satisfaction, the intricate capture unit was instrumented to a power subsystem. One day later we had a trigger and data to analyze. The oscilloscope which captured the zoomed in view of the incoming high voltage DC power had a very small disturbance for tens of milliseconds. The waveform was a fraction of a volt (few hundred millivolts). Yet with this small disturbance the output of the power module was ramping at a wild rate. This did not make any sense as this was a tiny disturbance in a 300V DC incoming voltage that had a 60hz 2V ripple as part of the normal design conditions. This is an equivalent of a flea on an elephant.

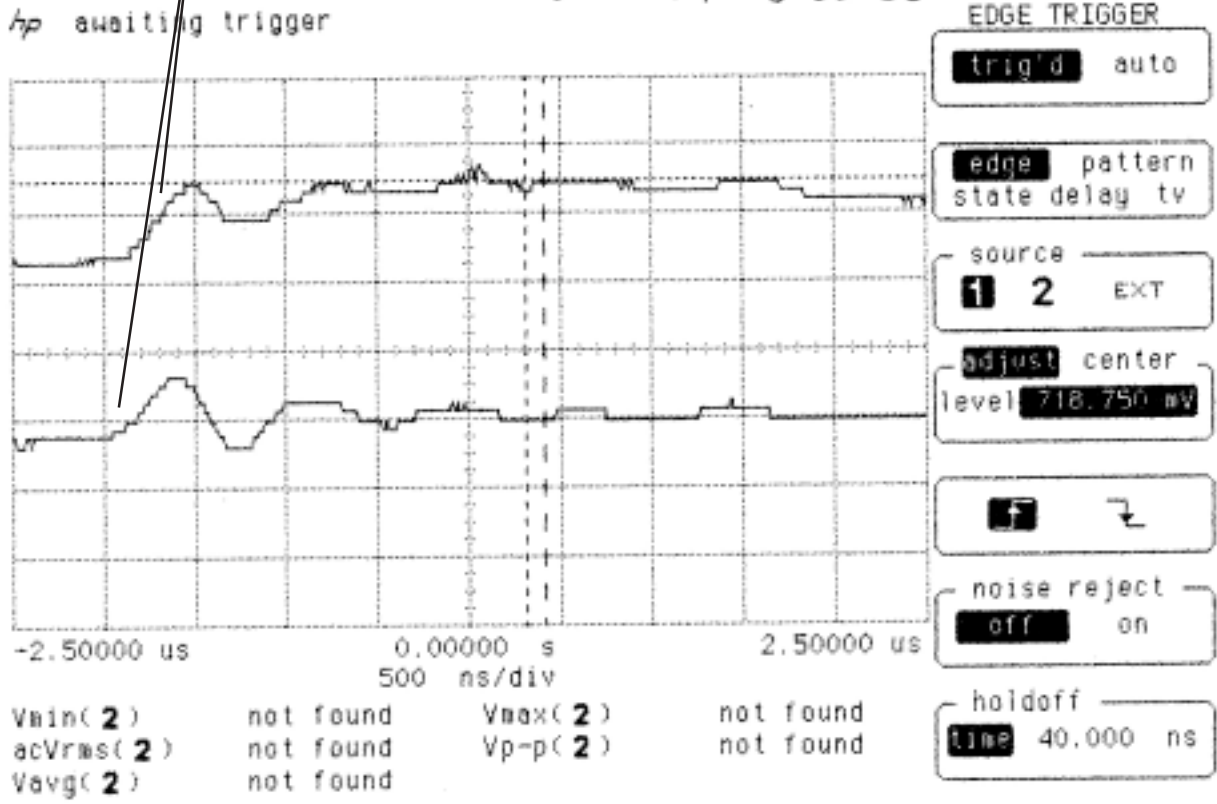
5-23-94 8:33:36

Top waveform shows 48V module output increasing, bottom waveform also shows disruption of 12V module output.

Trigger result from 'killer' energy reaching Power Module in supercomputer disk array. Waveform shows erratic behavior of internal power FET devices by the output waveforms.

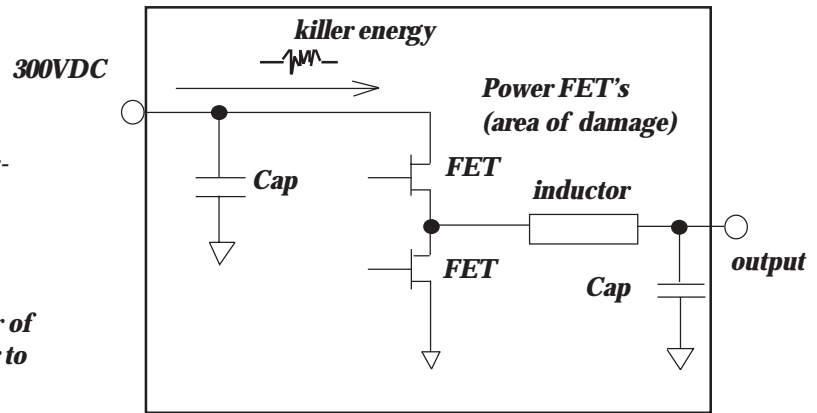
(simplified power module view)

Killer energy enters through 300VDC path & results in destructive behavior by power FET's. Behavior of waveform to FET destruction indicative of excited excess electron/hole conduction (intrinsic) where normal behavior of FET operating conditions similar to extreme thermal excitation.

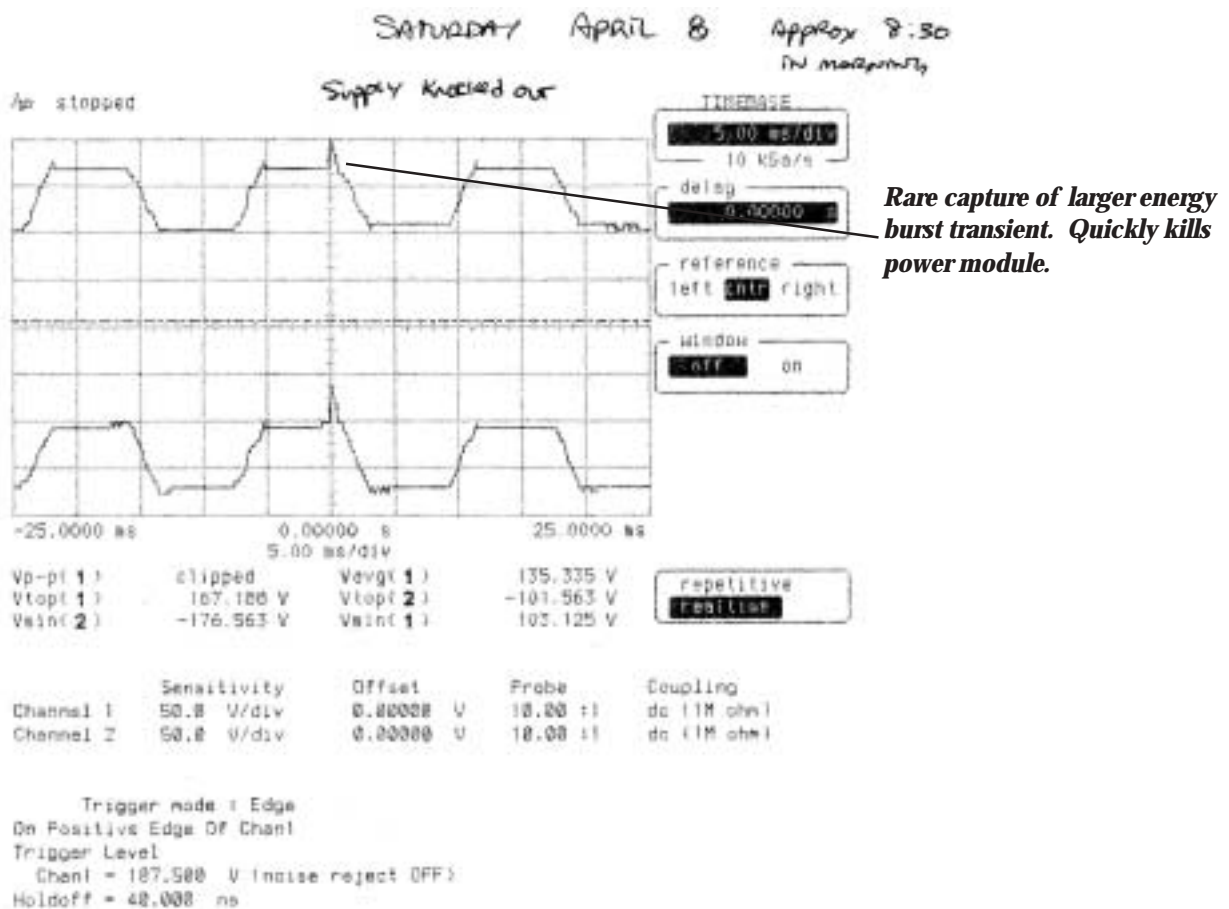
Incoming earth energy transient causes power FET's to switch wildly - boosting output voltages.

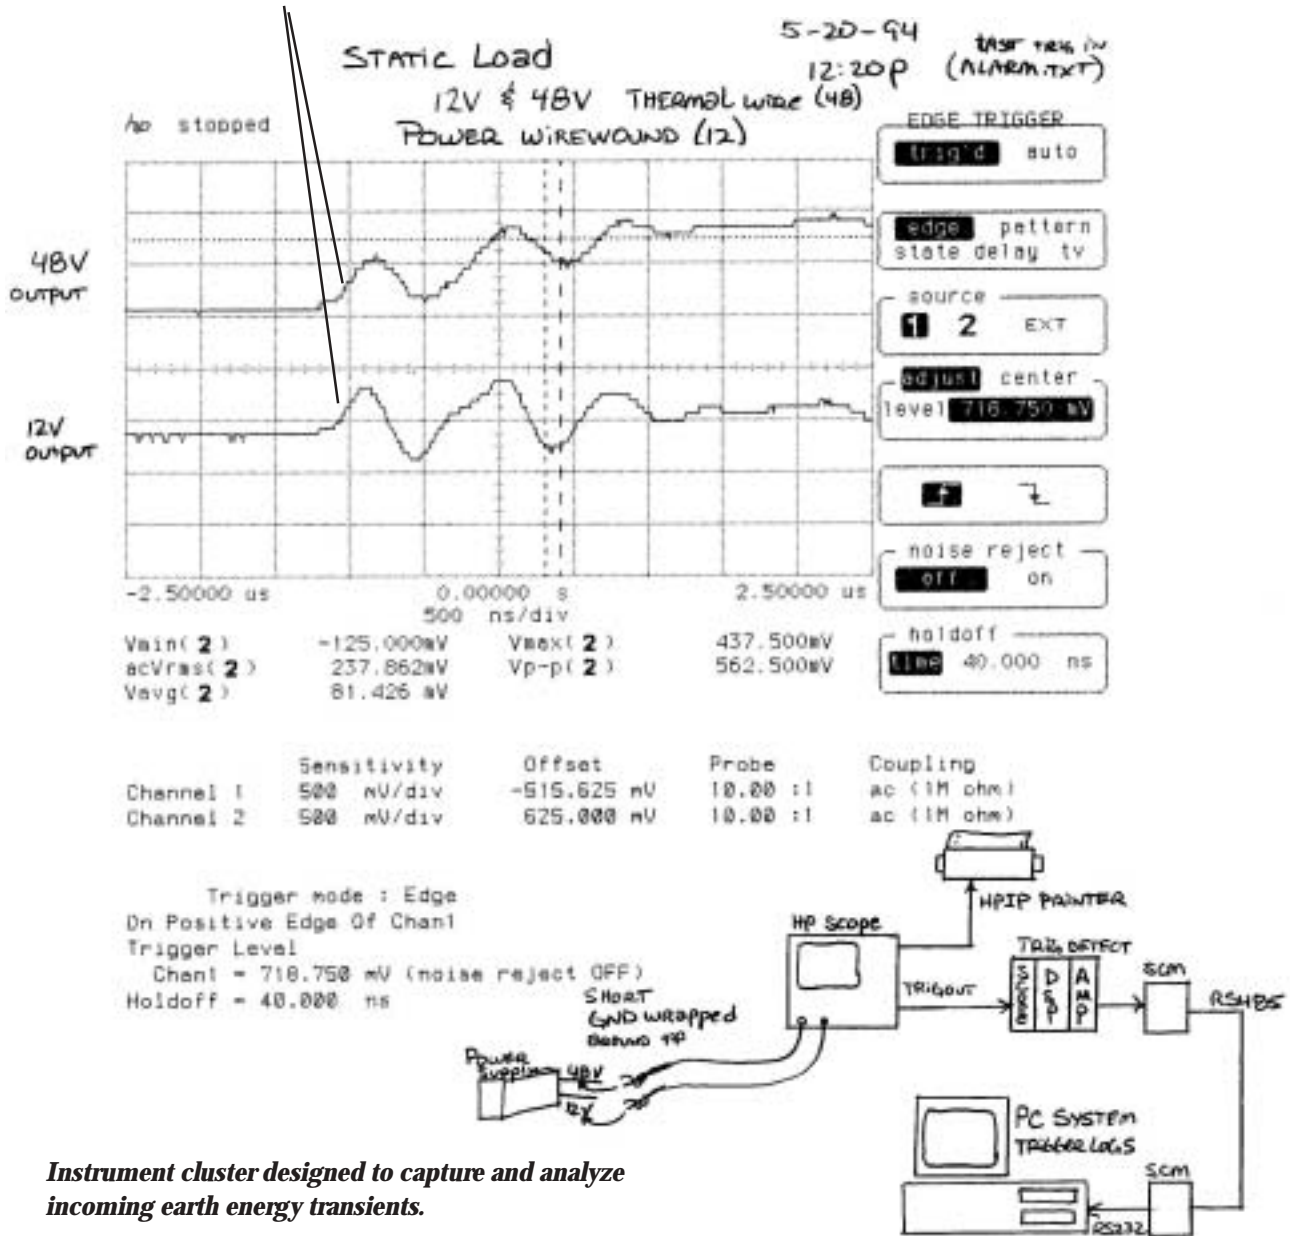
Instrument cluster designed to capture and analyze incoming earth energy transients.
